MAJORS, INCIDENTS, FORCED AND PRECAUTIONARY LANDINGS • 1 JULY 66 THROUGH 30 JUNE 67

CH-34 and CH-37 accident summary

THE UNITED STATES ARMY BOARD FOR AVIATION ACCIDENT RESEARCH • FORT RUCKER, ALABAMA

CH-34 and CH-37 Aircraft Accident Summary

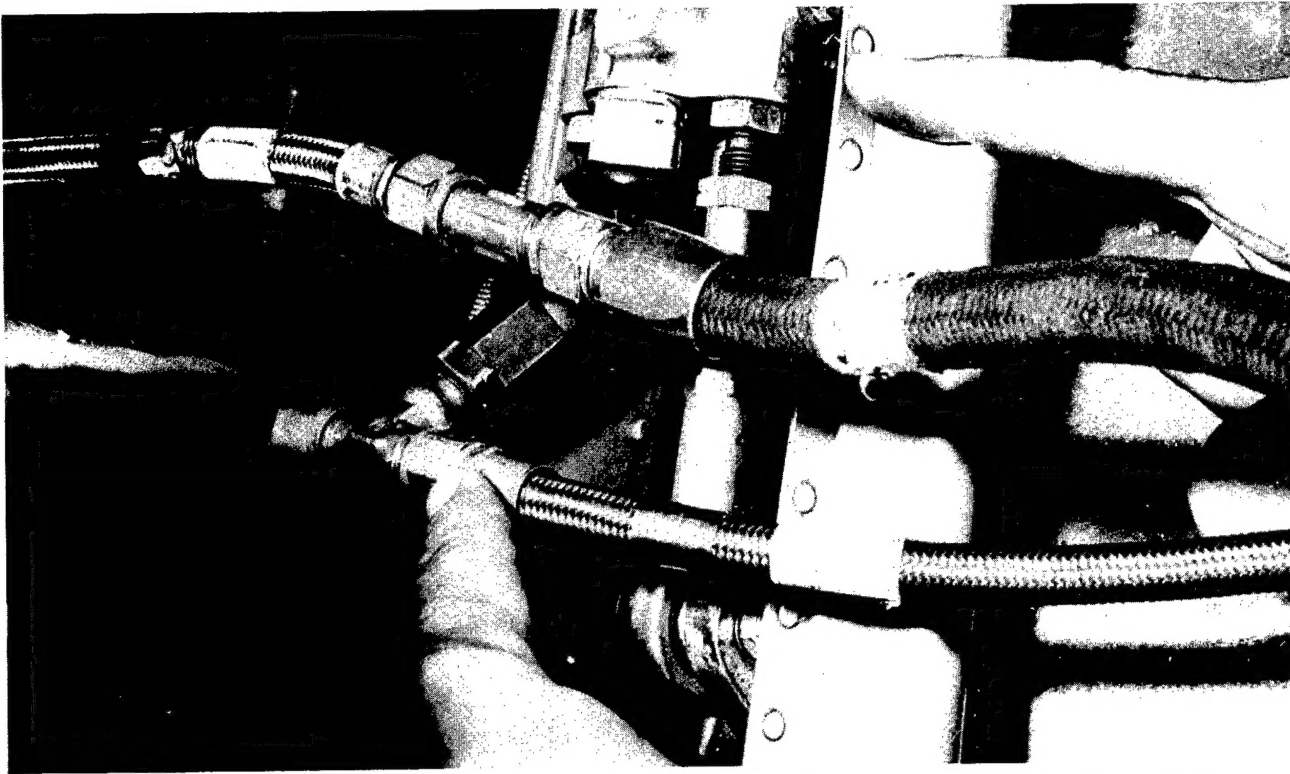
F542—Accident occurred during ground runup phase of a maintenance test flight to check out replacement of a left lateral primary servo. Preflight was accomplished with no discrepancies noted. Engine was started and warmup was normal. Rotor was engaged, but two attempts were required to complete engagement. RPM was established at 1700-1800 and maintained to allow clutch to drain, then a flight control check was made. The cyclic was moved fore and aft and during forward movement, the collective pitch moved upward about 3 inches. Primary servo was turned off and cyclic was moved about again, but no difficulty was encountered. Servo selector switch was moved from "primary off" to "both" to "auxiliary servo off." When the auxiliary servo was switched "off," the collective pitch began to rise. Pilot was unable to push the collective down, and attempted to close throttle to reduce rpm while applying down pressure on the collective. Aircraft became light on its main

landing gear, moved slightly rearward and left, and rolled over on left side, damaging tail rotor, tail pylon, main rotor blades and head, and three bell-crank assemblies. Pilot had minor injuries. Caused by improper installation of primary servo system pressure and return hydraulic lines. The low pressure hydraulic return line from the hydraulic reservoir was attached to the high pressure port of the left lateral servo, while the high pressure line was attached to the low pressure port of the left lateral servo. Other causes were (1) local maintenance supervisor did not adequately supervise or properly check completed installation of the left lateral primary servo, including pressure and return lines, (2) technical inspector failed to detect the incorrect installation and accepted installation, (3) neither the crewchief nor the maintenance test pilot detected the incorrect installation during preflight, and (4) use of improper technique in overcoming malfunction.

F542 Collective could not be lowered due to improperly installed primary servo system pressure and return hydraulic lines.

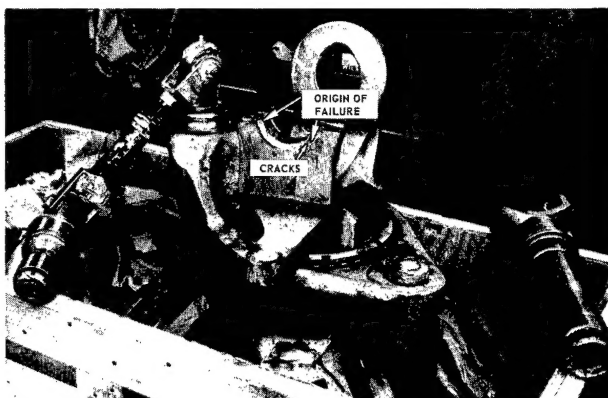
H798—Two CH-37Bs were flying at about 600 feet en route to destination. After 2½ hours, the lead aircraft began descending and turning left from 210° to 150° at a rate consistent with a normal landing approach. Rate of descent increased greatly at about 100 feet, and rotor assembly and transmission seemed to separate from aircraft about 15 feet above the ground. Aircraft, which was in a nose low attitude, was consumed in a ball of fire on or just prior to impact and was destroyed. Pilot, copilot, and crewchief killed. Caused by (1) fatigue failure of rotor head spindle through the aft pin hole, occurring from low overstress fatigue mechanism induced by high residual tensile stresses around outside hole periphery, and (2) lack of quality control.

H798 Rotor assembly and transmission separated from CH-37B due to fatigue failure of rotor head spindle and lack of quality control.

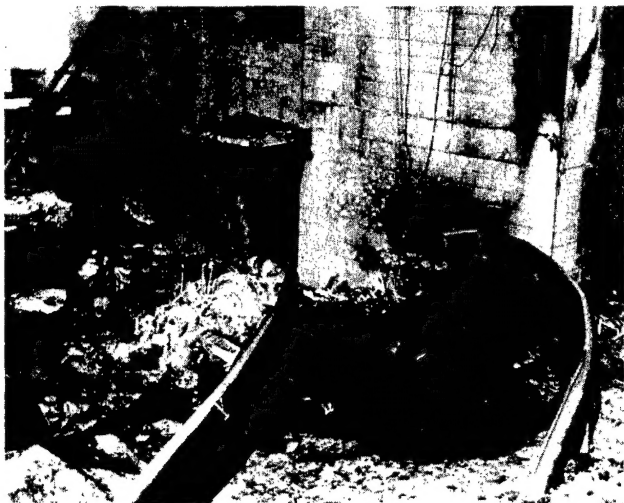
020903—A high reconnaissance was made of landing site, and a turn to final approach was made to a heading of 240°. On short final, aircraft descended below the desired approach angle, and the twist grip

020903 Improper pilot technique in applying power.

throttle was applied. Descent continued to increase and rpm was lost. Full overhead throttles were applied, but with little effect. A right turn was made for a go-around to gain airspeed and rpm. As aircraft passed over helipad, tail rotor blades struck right corner of pad. Aircraft passed through security fence, coming to rest about 150 feet down a steep slope between two buildings and burned. One occupant had major injuries and two had minor injuries. Caused by improper technique in power application.
